Vehicle Inspection Report

WA18 TOV
Ford Tourneo Custom 310 Ti Tdci A

Inspection Ref: [REDACTED]

03/05/23

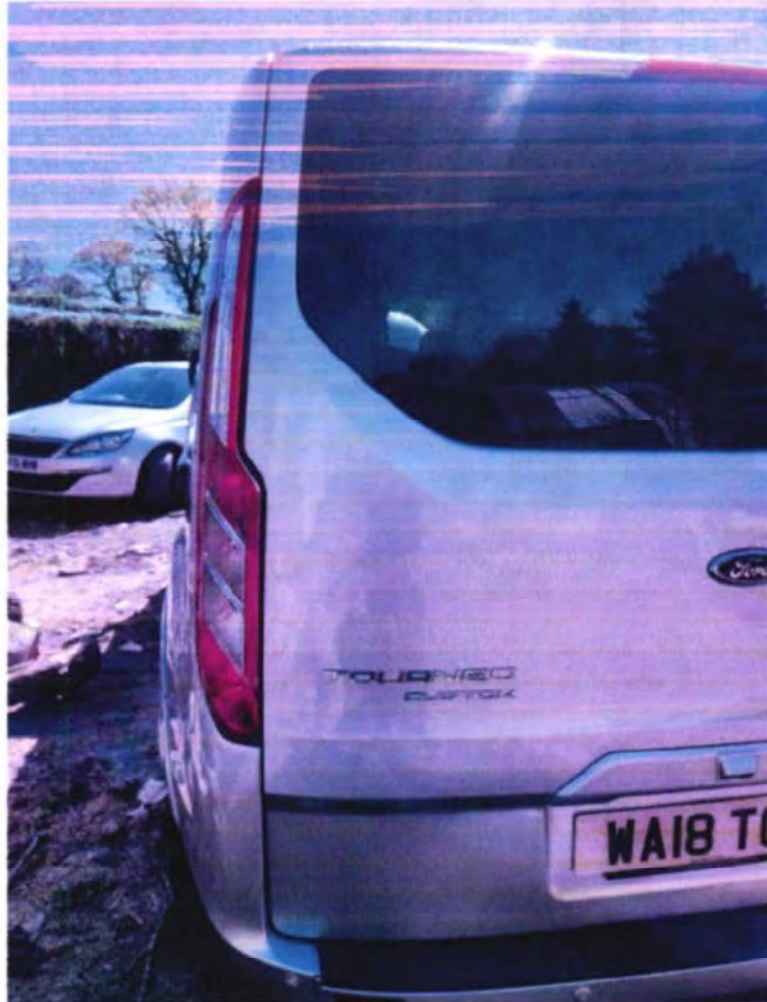
Rear Light Unit

- Coolant level/condition – coolant level below minimum mark.
- Antifreeze: protection low, -7°C .
- Engine oil leak front and underside.
- Nearside-rear light cluster faulty (stop lights, indicator/hazard lights/sidelights/running lights); all lights are dim.
- Rear screen washer inoperable.
- Droning noise from offside-front, over 30-mph; further investigation is required.
- Brake-pad warning-light on dash.
- Brake-pad wear warning-light on.

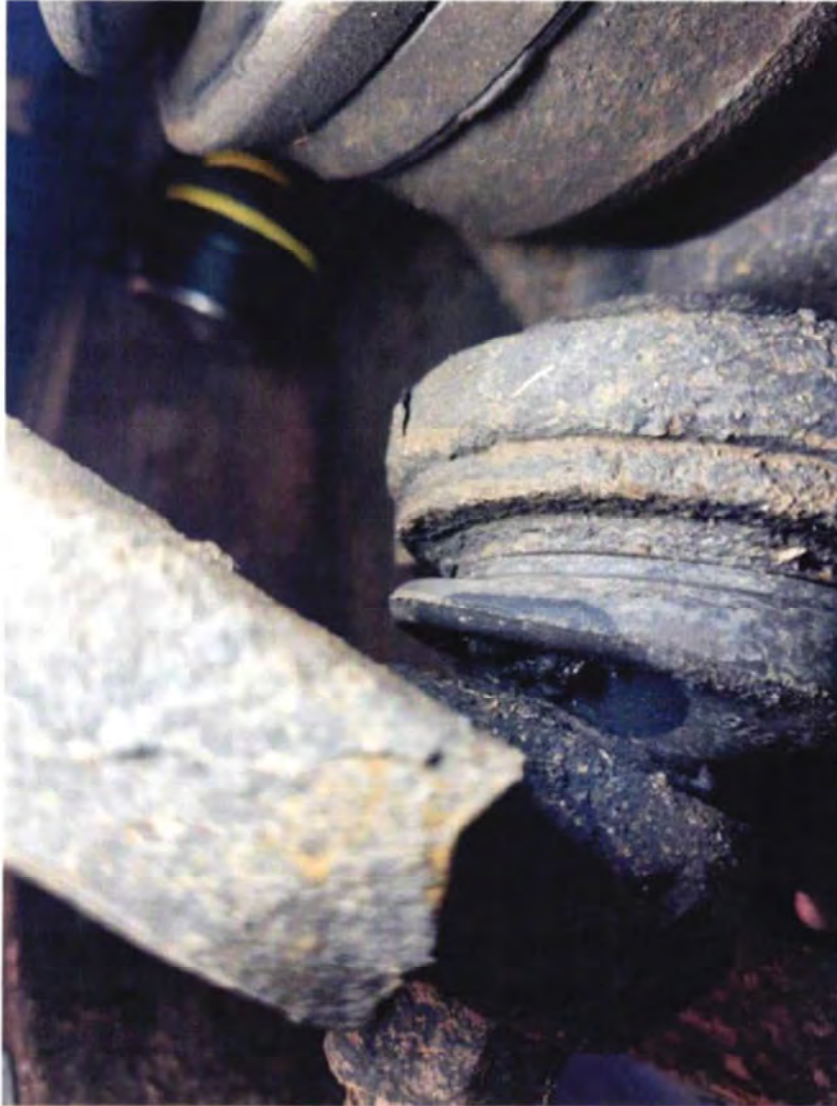
Ball Joint Condition

- Offside-rear window glass scratched.
- Battery voltage low.
- Stone-chips to windscreen.
- Cranking voltages low.
- Slight oil leak transmission.
- Nearside-front lower ball-joint has grease egress.
- High mileage vehicle.
- Alloy-wheels – scuff-marks
- Please see Bodywork and Interior Comments.

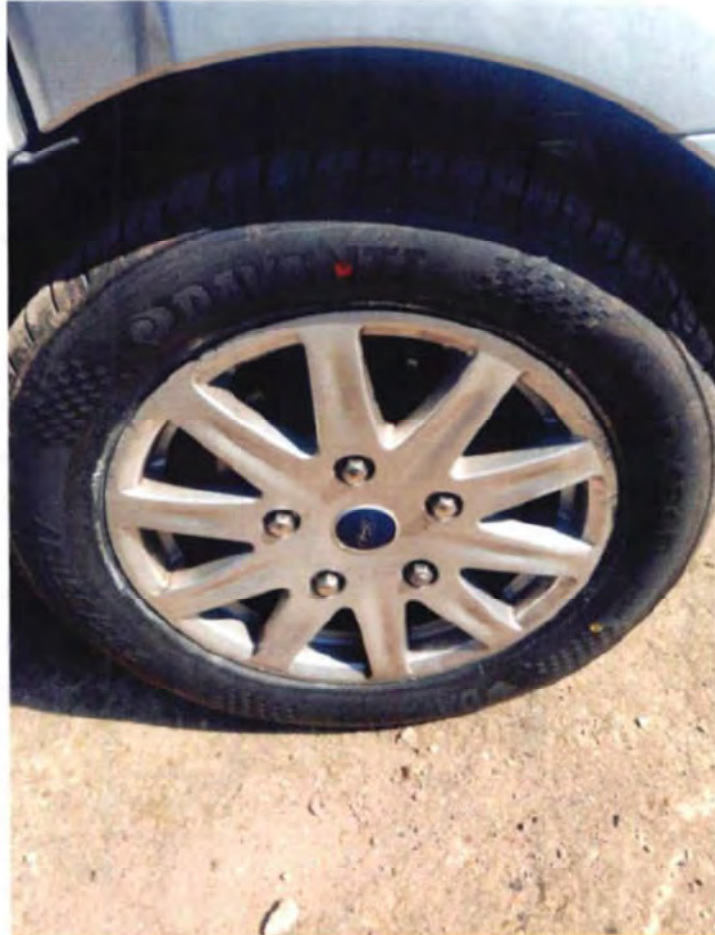
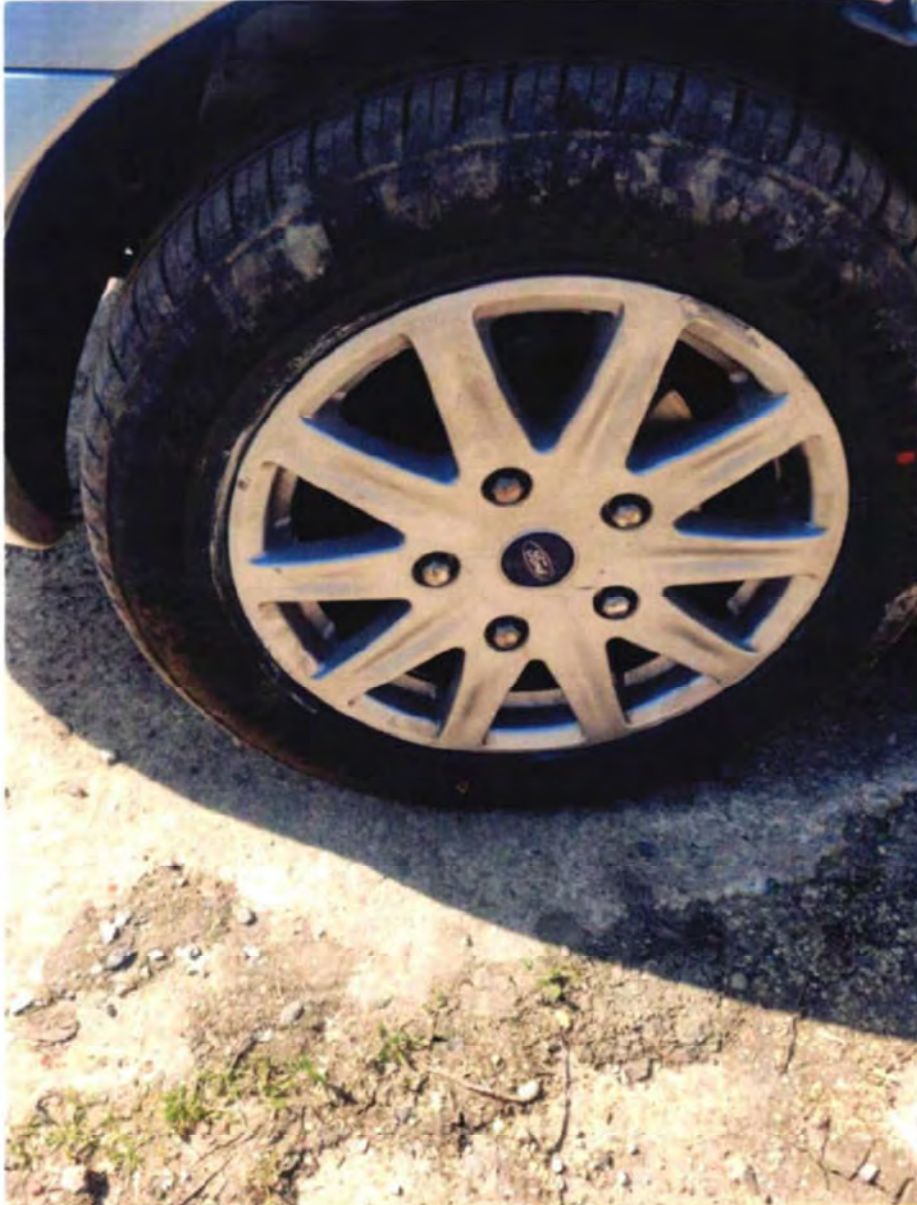
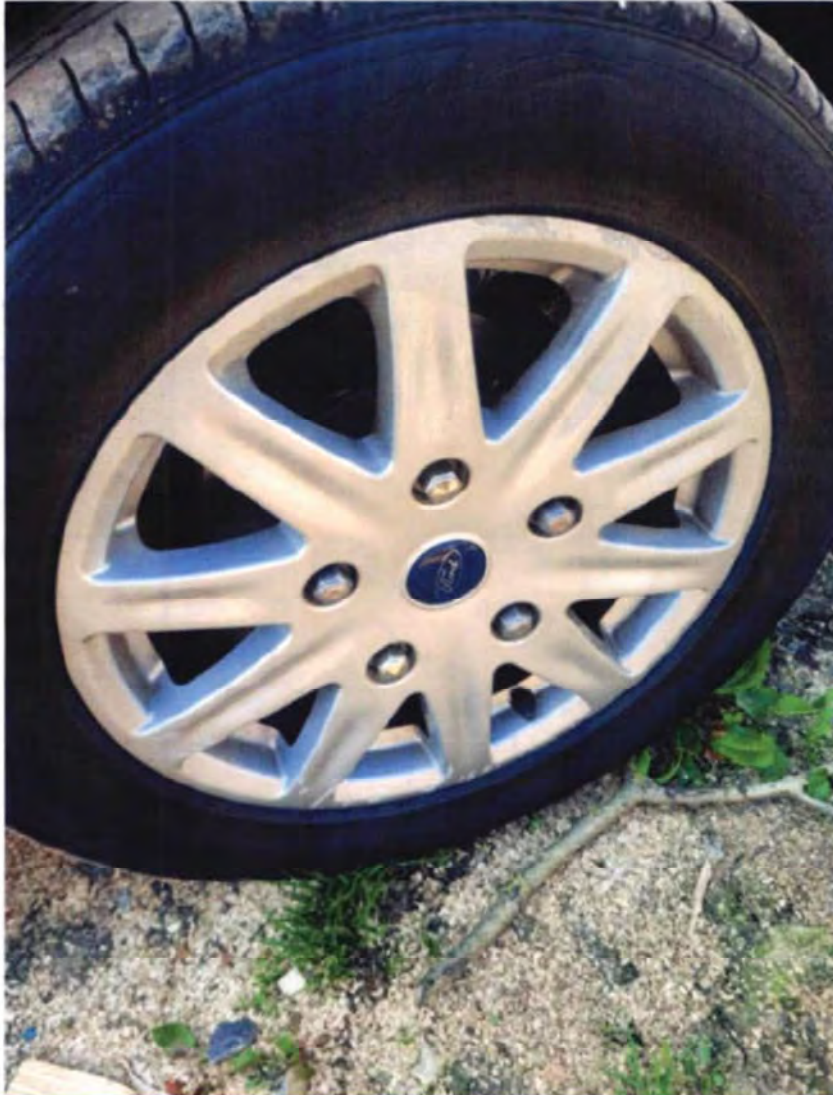
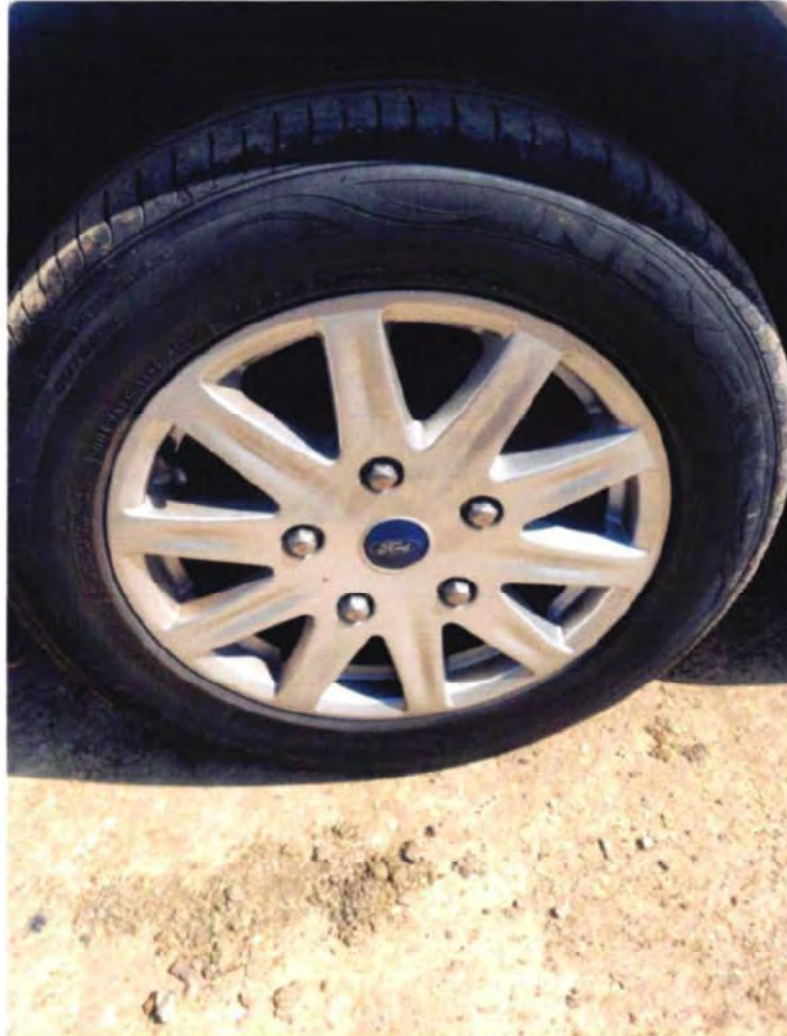
Alloy Wheel Condition

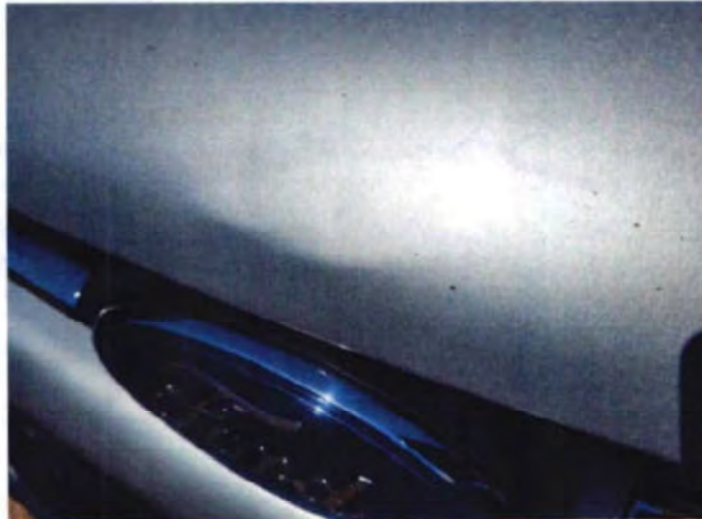
Stone Chips Dent

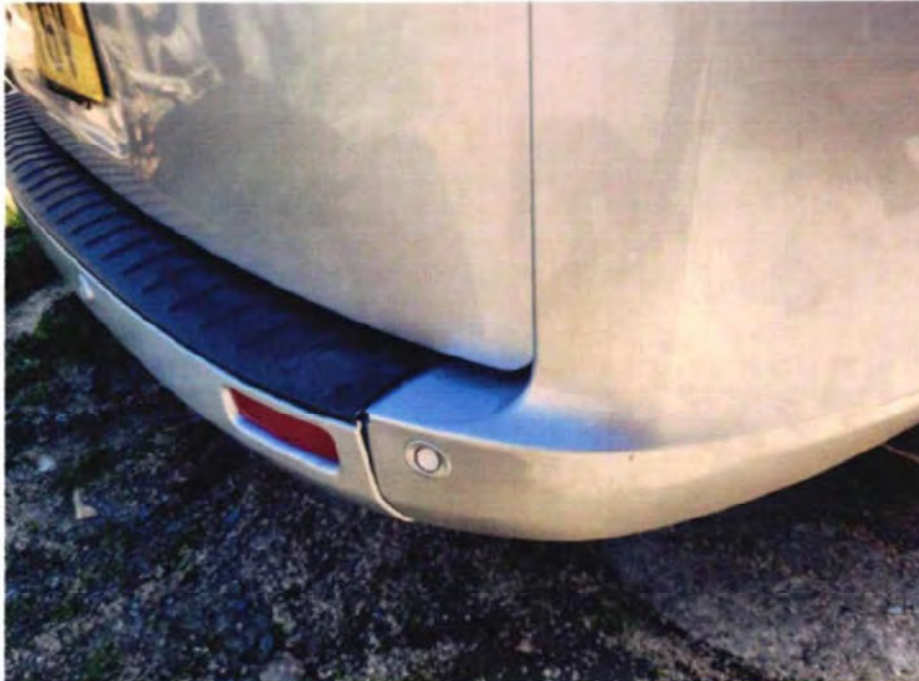
Paint Chip Panel not fitting

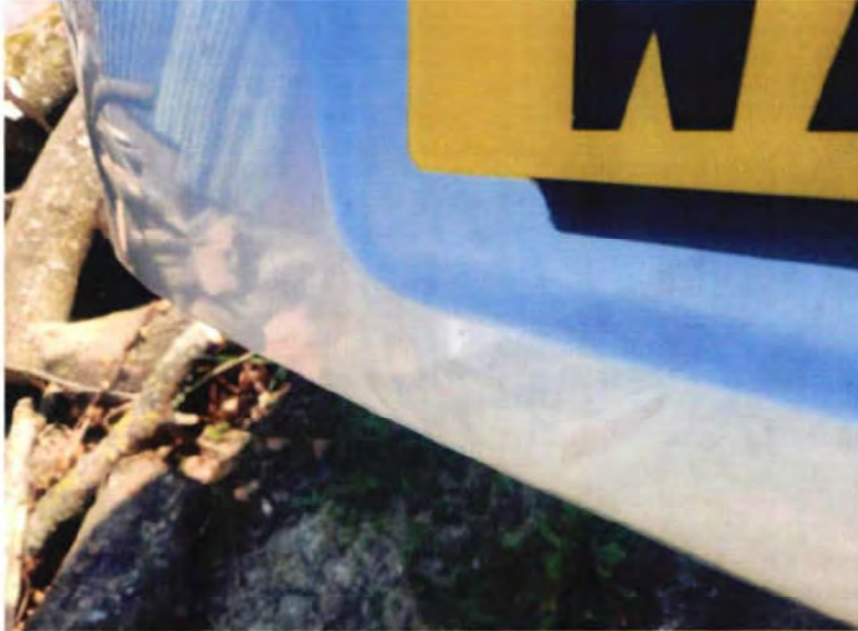
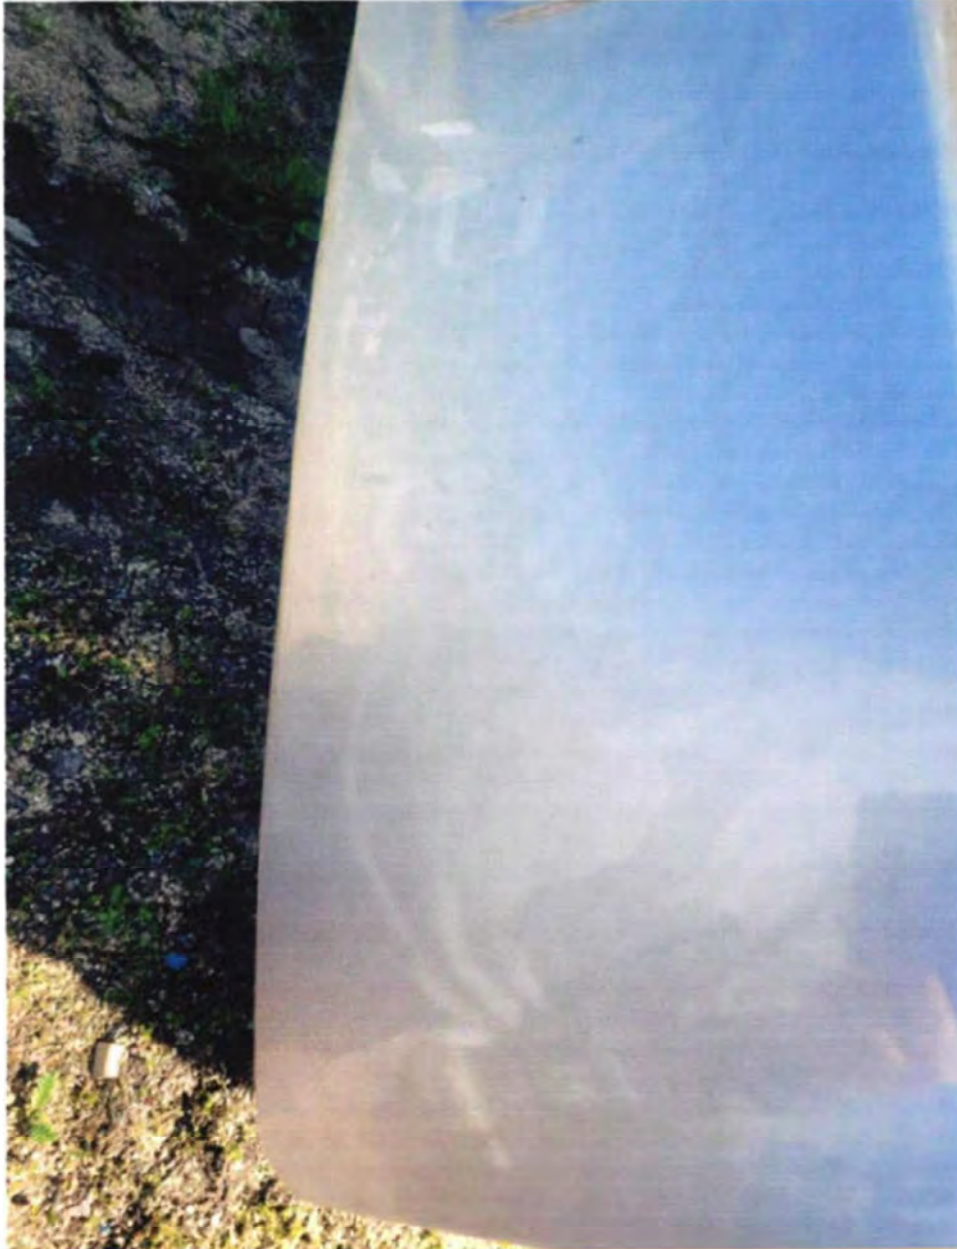
Paint Condition
