# Proposal: to accept land transfer of Top Pool (or Lamb's Pool), Holyford Woods, and to incorporate it into the management parcel of Holyford Woods Local Nature Reserve.

# **RESERVOIR DAM INSPECTION**

Holyford Woods, Seaton

for: East Devon District Council Document ref: XEDD2296/PD02 March 2012

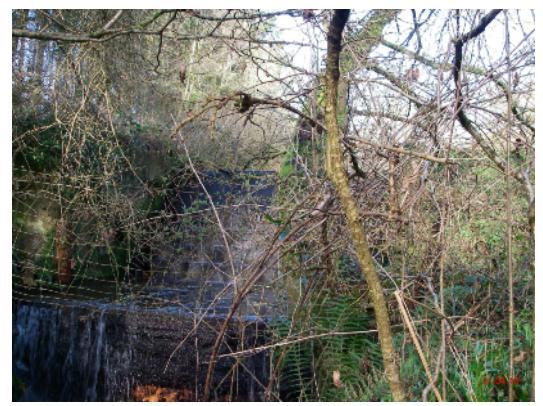
Photo 1

3.1 A preliminary visit was made on 1 April 2010 by Ian Jolley CEng FIStructE MICE RMaPS in the company of Fraser Rush of East Devon District Council. The area around the dam was heavily overgrown and although a general walkover was carried out and some photographs taken (Photo 1) it was agreed that some clearance work would be carried out by EDDC in order to be

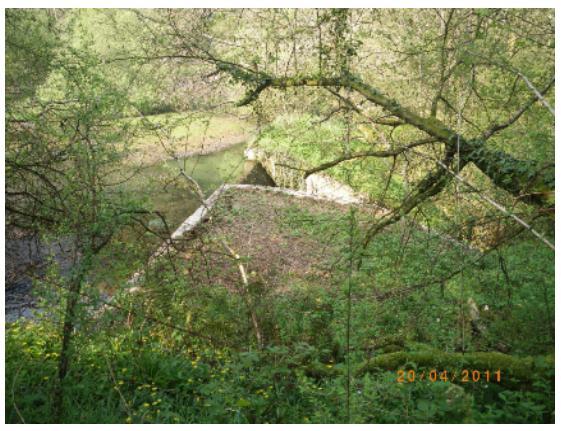
Photo 2

but there was still a general groundcovering of grasses, ferns and nettles, etc and a number of trees of varying sizes on and around the embankment (Photo 2).

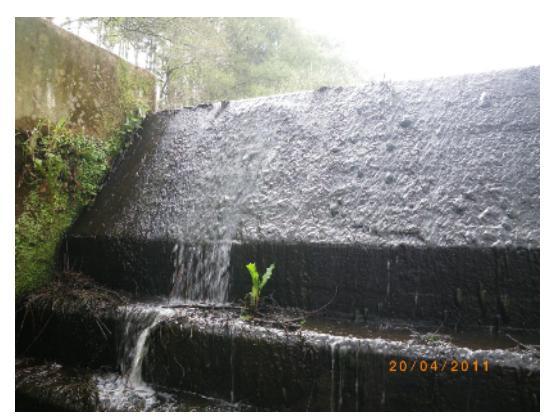
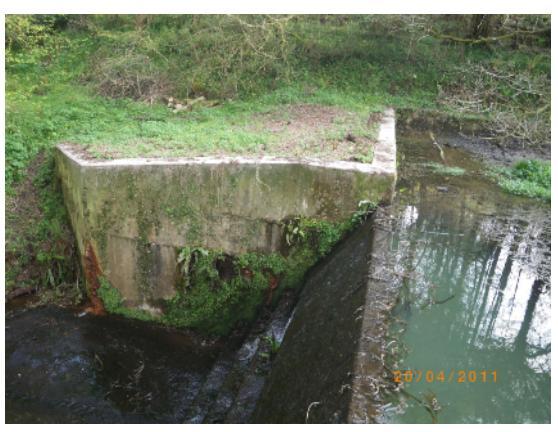
3.4 At the time of all 3 visits, the reservoir was full and there was a small amount of water running over the top of the weir (Photos 3 & 4).

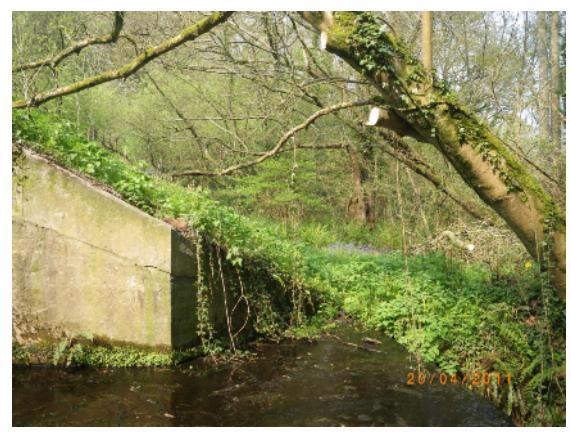
Photo 6

- 3.5 There was no visible evidence of soil movement/slippage on the downstream face of the embankment at the crest and toe, and no signs of significant animal burrows in the face. Although there was no evidence of running water seepage through the embankment, the ground in one localised area at the foot of the embankment was quite damp and spongy near to three fairly large trees.
- 3.6 At the time of our April 2010 inspection there was a large tree near the end of the right hand weir wing wall which was leaning towards the weir (Photo 6). By the time of our March 2012 inspection, the tree had collapsed onto the wall, with its branches lying in the reservoir (Photo 7).

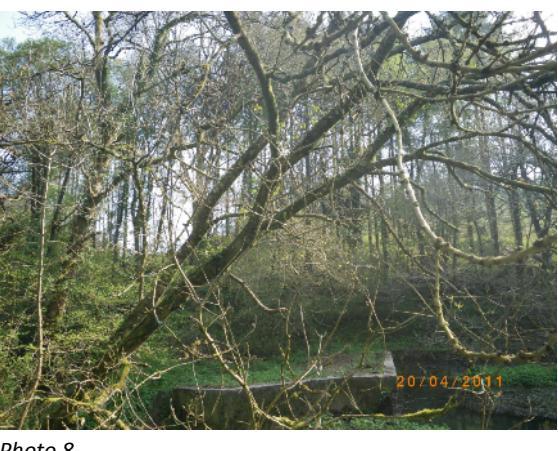
Photo 8

3.7 There are a number of smaller trees growing on the face of the embankment, the largest of which is near the embankment crest beyond the right hand wing wall and is leaning out over the water (Photo 8).

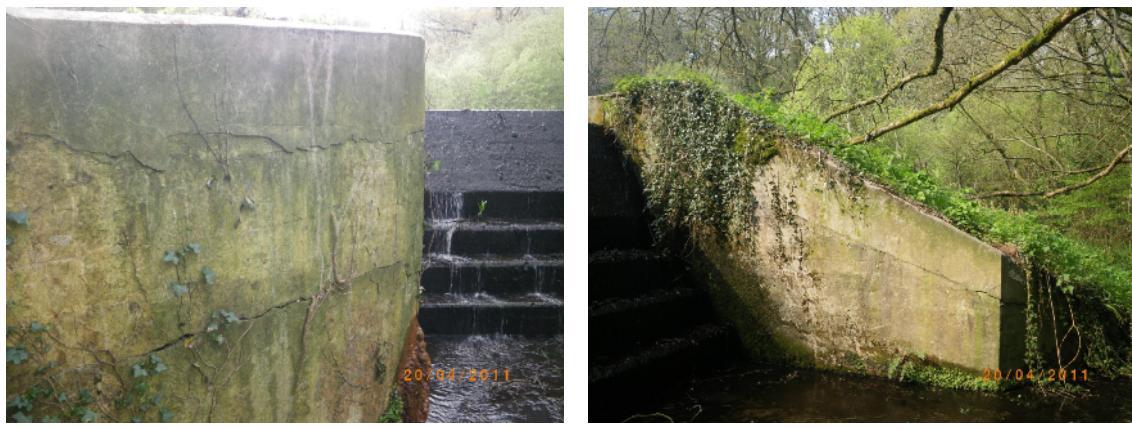
3.8 Each of the inner faces of the weir wing walls had horizontal and sloping cracks parallel to the tops of the walls, which corresponded with the construction joints which would have been formed in 1941 between the original and increased wall heights (Photos 9 & 10)

It also appears that when the piling and concrete capping was constructed in front of the embankment in 1956, some additional concrete was also added to the top of the left hand wing wall (see Photo 9), and the wall on this side is higher than the right hand wall by this amount (about 450mm). The ground behind the left hand wing wall was level with the top of the wall, suggesting that the ground here was also raised in 1956.

- 4.14 The cracks in the spillway wing walls which follow the construction joint lines for the 1941 raising works, although unsightly, do not give cause for undue concern. The drawing doesn't indicate whether there was any drilling of tie bars into the tops of the original walls prior to placing the new concrete and in fact doesn't indicate whether the new concrete was reinforced at all. Nor is there any detail of how the joint between the two sections was to be formed. The resulting cracks along the joint lines are therefore not unexpected. The walls behind the weir i.e. the ones raised in 1941 are not required to resist water pressure from the reservoir, and only carry load from the additional 530mm height of ground retention.

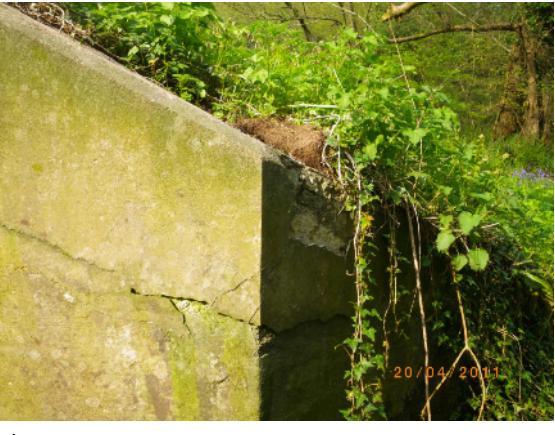
Photo 11

3.9 The faces of the downstream wing walls were reasonably plumb and in good alignment, but were spalling in places. However, it appeared that the loose surface was a cement render, albeit extremely thin. The worst damage was on the right hand wall at the 45° change of direction where the render thickness varied from about 12mm at the top, feathering to zero at the bottom (Photo 11).

- 4.15 Without details of the reinforcement in the original walls, we are unable to advise whether the additional retention height would create problems for the original walls. In general, there is no evidence that the walls are overloaded, nor that the reinforcement is suffering from significant corrosion. However, it appears that the walls had a render coat applied at some time, and it is possible that this was done to provide protection to concrete surface damage from whatever cause.

- 5.6 Whilst not an urgent requirement, we recommend that as part of a future maintenance programme, the damaged render on the downstream wing walls is removed in order that the concrete substrate can be examined, and a view taken as to whether more effective repairs are necessary.

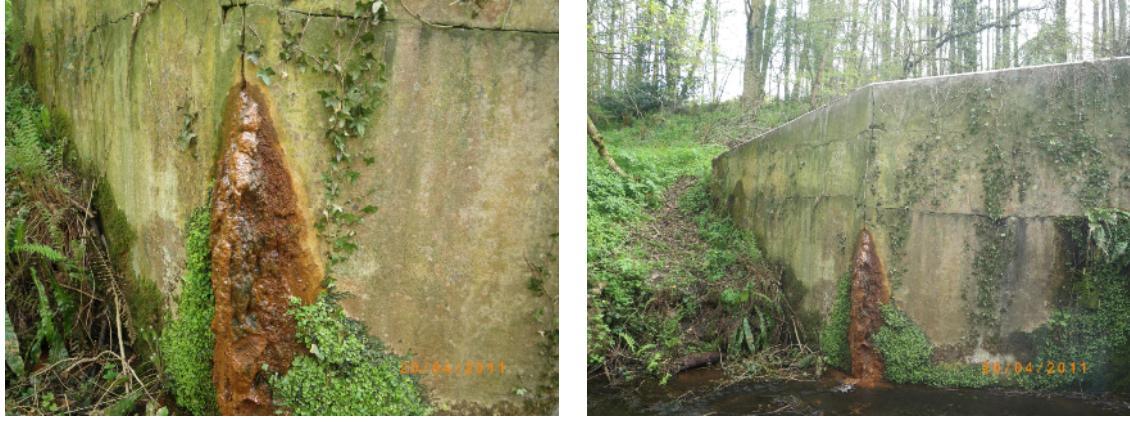
3.10 There was a vertical crack in the left hand wing wall at the junction where the wall splayed outwards at 45° on plan, and there was a large orange-brown accretion projecting from the lower part of the wall (Photos 12 & 13).

The material was very soft and appeared to be a clayey residue being washed through the crack from behind the wall. At the time of our most recent visit in March 2012, the accretion had increased slightly in bulk and there was a constant dripping of water from the crack (Photo 14). The crack itself was about 6mm wide at the top of the residue, and 10mm wide at the top of the wall (Photo 15). There was no discernible increase in the crack widths between our visits in April 2011 and March 2012.

- 4.16 A possible exception to the observation above regarding lack of wall damage from increased retention is the vertical crack and wash-out accretion on the left hand wing wall at the 45° junction. The retention height behind the left wall is greater than on the right, and on this side is in the order of 1m higher than the original walls were required to support. The tapering crack is indicative of rotational vertical movement of the wing wall, causing separation at the splayed corner. However, the plan form of the wall with its splayed end and its connection to

the weir wall makes for a reasonable robust structure, and we do not consider that the wall is in danger of imminent failure. Whilst it is possible to grout or otherwise seal the crack, this would not achieve a solution to any continuing movement and would essentially be cosmetic. The crack is likely to recur.

- 4.17 It is not clear whether the water dripping from the crack in the wing wall is coming from the reservoir or from the surrounding ground. However, the 1956 piling protection works do not appear to have been carried out to the left of the weir wall. Thus, the resistance to seepage under this part of the dam structure is provided only by the original clay puddle core under the earth fill within the arms of the left hand wing walls. It is therefore probable that the water coming from the crack is seepage from the reservoir.

- 4.18 Whilst it is tempting to consider removal of some of the ground from behind the left hand wing wall in order to relieve the pressure on the wall, we would advise that this should be avoided. Removal of mass from the rear of the dam in this location, may risk comprising the local resistance of the dam to water pressure from the reservoir and might cause a local blow-out. Any removal of dam material should only be done in conjunction with draw down of the water level, and as part of other remedial work to prevent seepage. The risk of failure of the 'embankment' in this area under the current conditions, is not considered to be great, as the ground is effectively contained within the upstream and downstream wing walls.

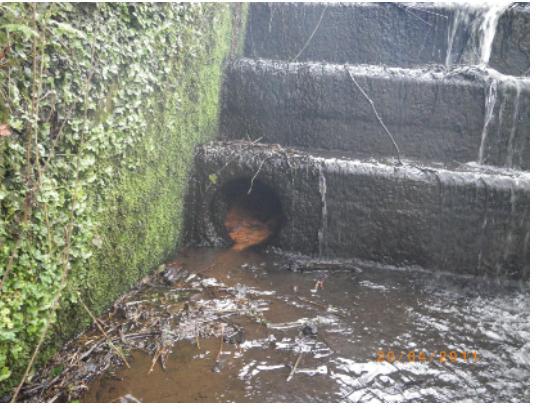
Photo 16

3.11 The reservoir's 9" (225mm) wash-out pipe noted on the drawings could be seen at the bottom left corner of the weir wall (Photo 16). However, there was no sign of a valve/penstock wheel

or spindle on the upstream side of the weir – and none is indicated on the drawings. There was a small amount of the orange-brown soft material in the bottom of the pipe.

- 4.11 Concerning draw-down, it was not possible during the inspection to identify the presence of a penstock spindle for a handwheel or crank handle to open the wash-out through the weir wall. It is possible that one remains out of sight below water level following the raising of the dam in 1941. However, even if there is a spindle, the penstock will almost certainly be impossible to open after 80 years of immersion. Should it become necessary to draw down the reservoir, this will need to be done by over-pumping using a temporary mobile pump set.

- 5.3 Assessment of the condition of the steel piling should be made, and this will require inspection by an experienced diver or draw-down of the reservoir. We do not consider this to be an urgent requirement, provided regular inspections of the condition of the dam are made, but should be included in the budget for future medium term maintenance. During maintenance work involving draw-down, consideration could be given to replacing the existing penstock to allow future wash-out and allow draw downs without the need for pumping.

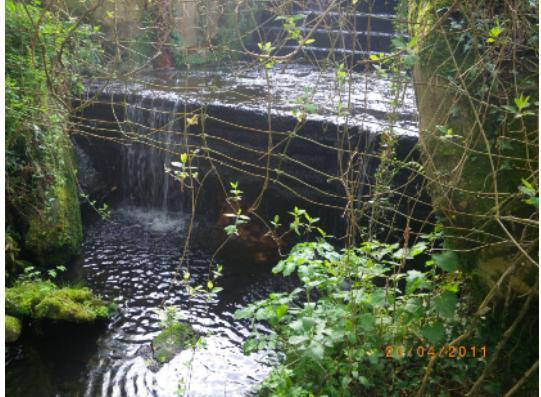
Photo 17

3.12 Although not shown on the record drawings, at the extremity of the downstream wing walls there is a 1.5m cascade down to the level of the stream bed (Photo 17).

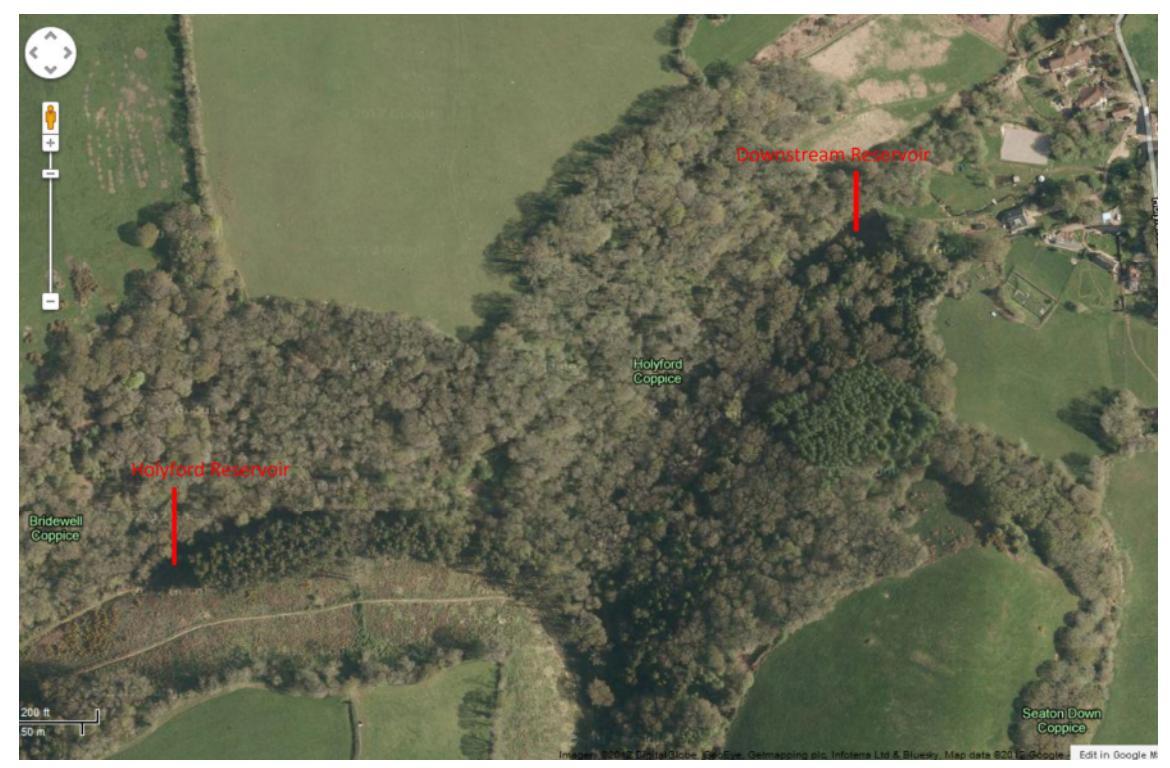
Fig 1

- 4.3 The consequences of failure of a dam depend upon many factors, including the volume of water, the height of the dam, and the slope and nature of the land downstream of the dam. Investigation of the consequences of failure of the Holyford Dam was not part of our brief, and is mentioned here as a matter for further consideration. The land immediately below the dam is a reasonably wide valley through the Holyford Woods which should be able to accommodate a significant volume of water. However, about 500m downstream of the dam is another impounding dam, located not far from a number of farmhouses and buildings (Fig 1).

The consequences of a sudden large volume of additional water reaching this second reservoir may cause the downstream one to either also fail, or at least overtop, with potentially serious implications for the residents and buildings downstream.
