# Proposal: to accept land transfer of Top Pool (or Lamb's Pool), Holyford Woods, and to incorporate it into the management parcel of Holyford Woods Local Nature Reserve.

# **RESERVOIR DAM INSPECTION**

Holyford Woods, Seaton

for: East Devon District Council Document ref: XEDD2296/PD02 March 2012

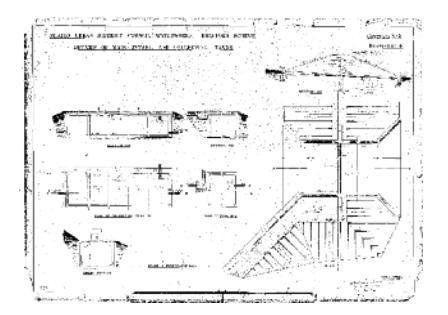
**Drawing No.4** by Rofe & Rafferty Consulting Engineers of Victoria Street, London – Seaton UDC Waterworks Holyford Scheme: Details of Main Intake & Collecting Tank:

There is no date given on the drawing, which appears to show the original outline construction details through the dam embankment and spillway. The upstream slope of the embankment is originally noted as 1 in 3 and the downstream slope as 1 in 2.5. Handwritten notes have altered these to 1 in 2.75 and 1 in 2.65 respectively, although the later drawings

(see below) indicate that the original gradients are the ones actually used. From the type of rc construction shown on the drawing, together with the historic maps, we would estimate the construction date to have been around 1930.

The spillway weir structure is located at the left hand end of the dam, with essentially all of the earth embankment to the right. The length of the crest of the embankment in its increased condition is about 96' (29m). Whilst there is earth fill to the left of the spillway, this is contained within the left hand wing walls of the spillway. Two thirds the way along the upstream left hand wing wall, there is a 3'x3' (0.9x0.9m) square chamber, although it's purpose is not indicated on the drawing (but see below).

The concrete spillway weir wall is 6' (1.8m) high and has a vertical upstream face and a stepped downstream face. The wall is 1'3" (380mm) thick at the top and 4'6" (1370mm) at the bottom. The weir has a central V-notch. The spillway has upstream and downstream aprons and wing walls extending 22'4" (6.8m) upstream and 24'1" (7.34m) downstream of the weir wall, and a central cut-off wall extending 6' (1.8m) below the bottom of the aprons. The leading and trailing edges of the concrete aprons have concrete downstand thickenings.

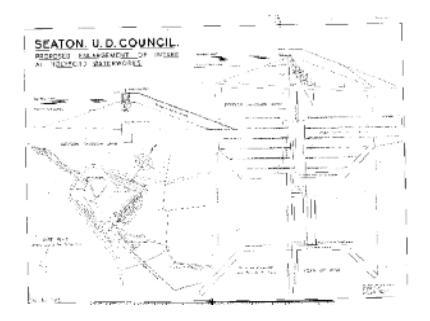
**Drawing No. 985** by Seaton UDC – Proposed Enlargement of Intake at Holyford Waterworks – dated October 1941:

Plan & Sections showing the proposed raising of the water level by increasing the height of the embankment and spillway by 3' (915mm). The Section through the embankment shows that the existing construction was of a central clay puddle core, with earth fill on the upstream and downstream faces. The embankment was to be raised by constructing a 1'6"

(457mm) thick by 5' (1525mm) high concrete wall above and partially into the central clay core, and providing an overlay of earth fill on the downstream face only.

The drawing indicates that the chamber on the left hand wing wall is a draw-off point for a pipe supplying water to the Collecting Tank downstream of the dam.

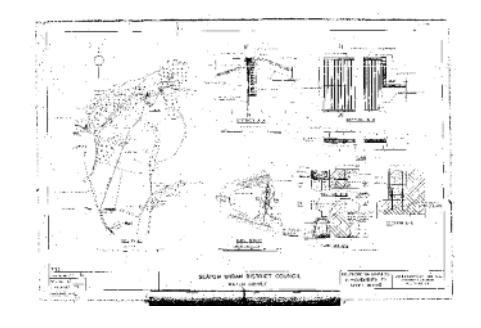
<u>Drawing No. NP/O/1/1</u> by JD & DM Watson, Chartered Civil Engineers, Westminster – Seaton UDC Water Supply – Holyford Waterworks, Improvements to Upper Intake – dated September 1956:

The drawing shows installation of steel sheet piling into the upstream face of the embankment along the front of the clay core and previous concrete wall, together with provision of a reinforced concrete capping beam bolted back to the existing central concrete wall. It appears that the work was to strengthen the upstream embankment face, and no further increase was made to the embankment height (but see 3.8 below).

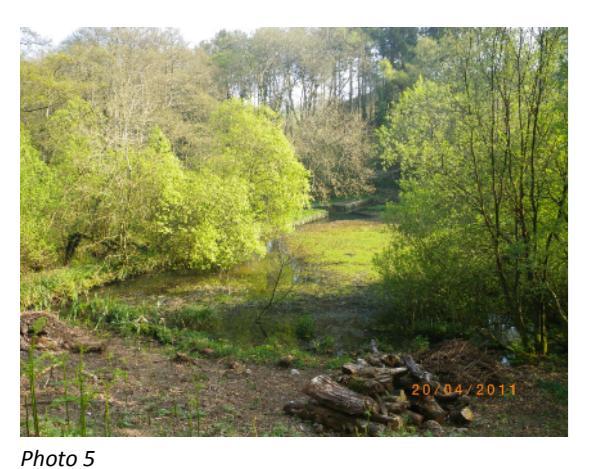
Because the reservoir was full and the water was very cloudy and had a lot of surface algae and pond growth, it was only possible to see a small amount of the upstream face of the embankment and weir structure above water level (Photo 5). However, it was possible to see the top ends of steel piles under a concrete capping beam running along the front edge of the embankment. The spillway wing walls on the reservoir side of the weir were not raised during the 1941 work and consequently, are

below water level. The tops of the walls were just visible under the water surface.
